STRUCTURAL INTEGRITY RESERVE STUDY

The Golden Isles Condominium Association, Inc.
700 Layne Boulevard, Hallandale Beach, FL 33009

Prepared by: Gregorio Batista, PE, CGC, and Kristian Cano
Inspected on: June 13, 2024
Prepared on: June 13, 2024

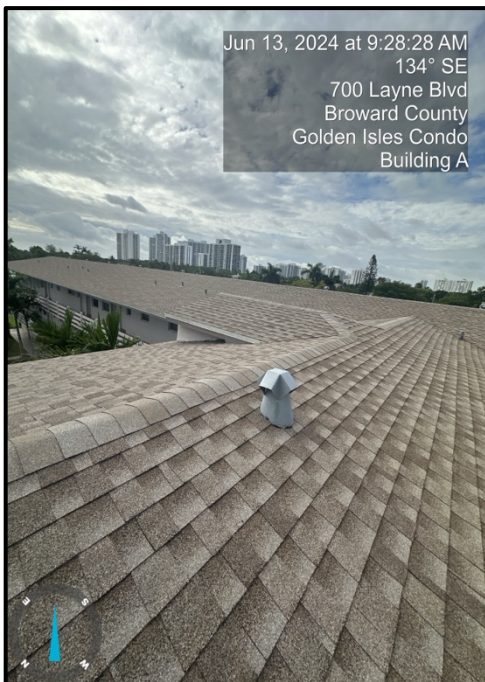
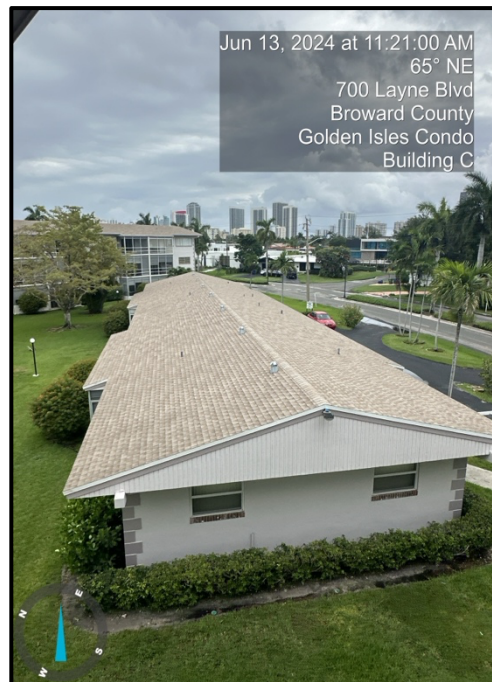
ROOFING SYSTEM

Condition: The roof appears to be in satisfactory conditions.

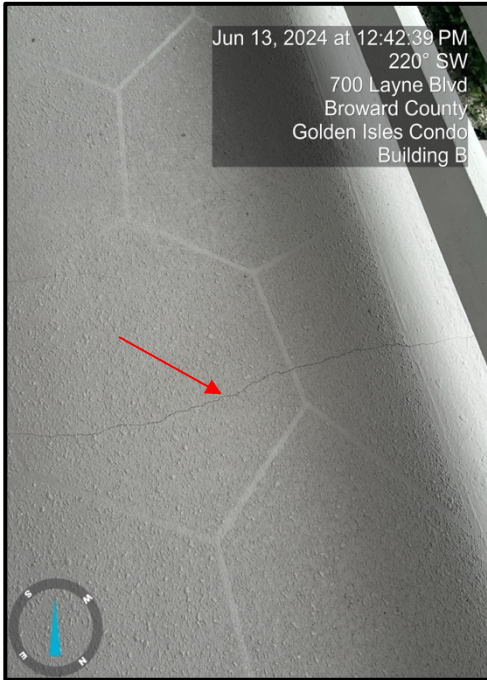
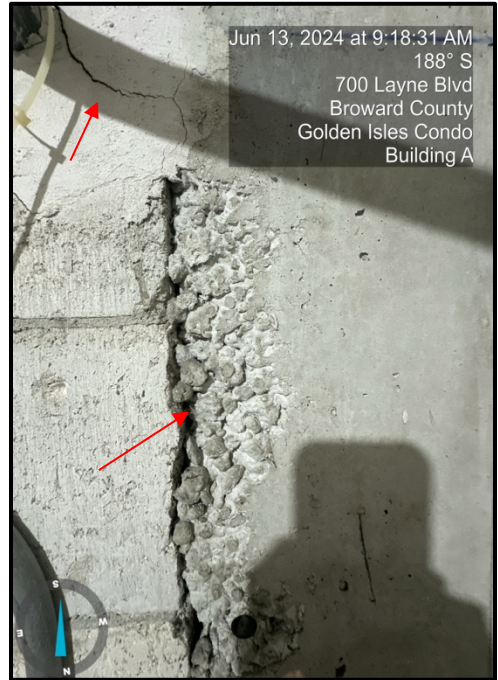
STRUCTURE, LOAD-BEARING WALLS, AND PRIMARY STRUCTURAL SYSTEMS.

Condition: The concrete framing and floor systems is in fair condition.

Remaining Lifespan: Although concrete is a very durable material, due to the location's proximity to the coast, spalling due to rebar corrosion usually manifests before the concrete naturally deteriorates. It is important to note that it is rarely possible to visually inspect and examine all the concealed construction, nor should be generally necessary. Our conclusions are based upon our experience and conditions examined in the exterior typical structural members of the building. Refer to the table presented at the end of this report.

Estimated Cost of Replacement: Concrete repairs are typically done on a unit-price basis and should be repaired as damages appear. Refer to the table presented at the end of this report for our recommendation based on our experience and the size of the building.

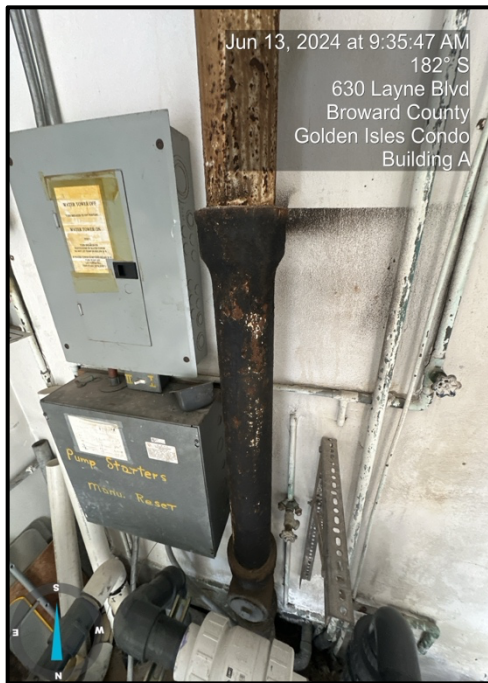
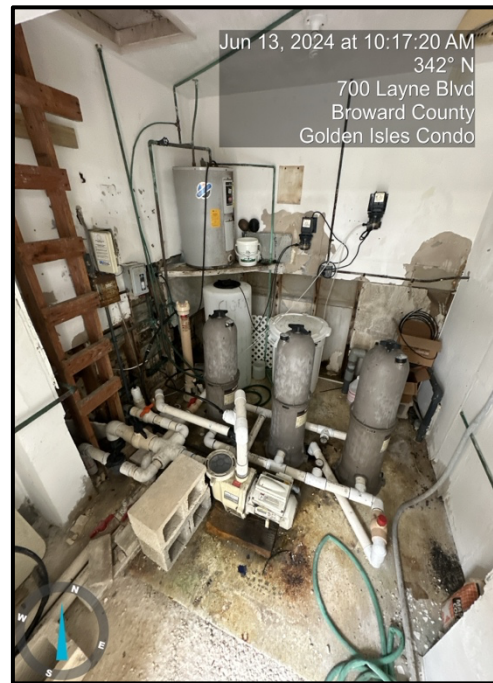
PLUMBING

Condition: The plumbing system in fair condition. It is important to note that it is rarely possible to visually inspect and examine all the concealed construction, nor should be generally necessary. Our conclusions are based upon our experience and deficiencies found in the visible and readily accessible areas.

Estimated Cost of Replacement: Plumbing lines and systems are typically not replaced in their totality but are repaired as items appear. See the table presented at the end of this report for our recommendation based on our experience and the size of the building.

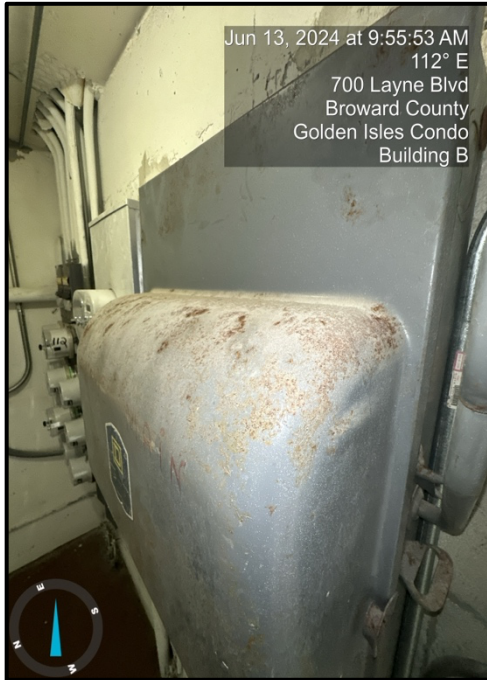
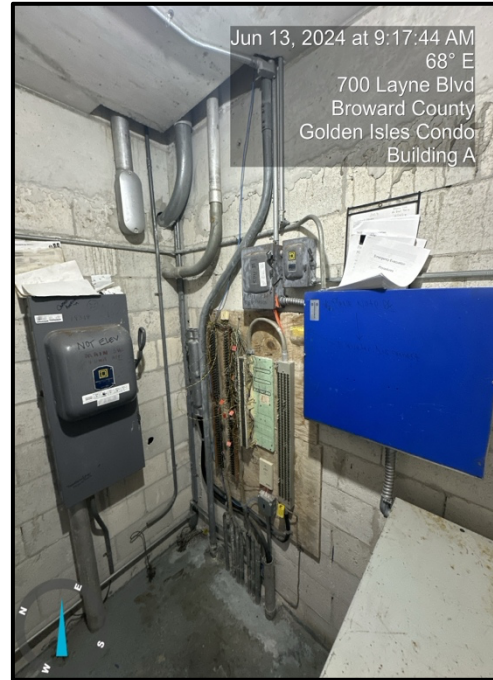
ELECTRICAL SYSTEMS

Condition: The electrical system(s) is in fair condition.

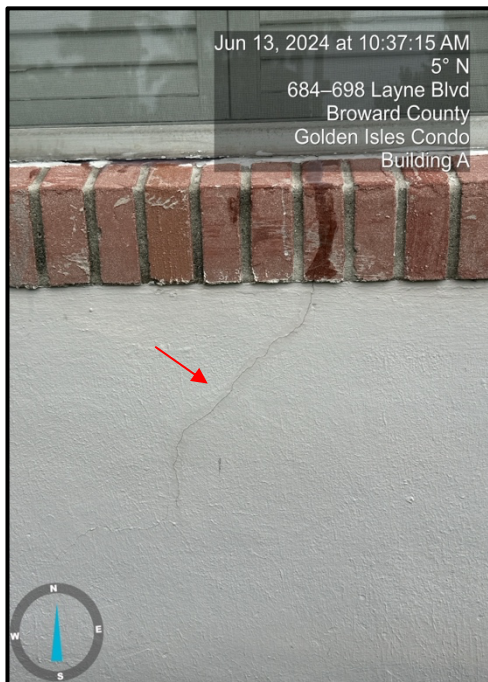
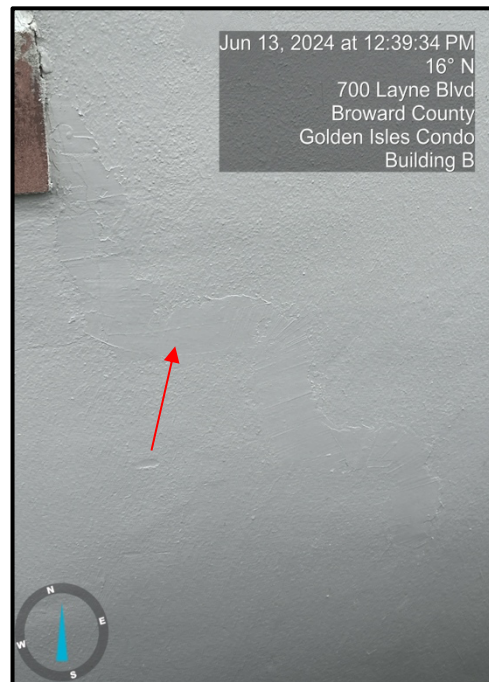
EXTERIOR ENVELOPE FINISH - STUCCO

Condition: The exterior stucco is in fair condition. It is important to note that our conclusions are based upon our experience and deficiencies found in the visible and readily accessible areas.

Remaining Lifespan: Although the stucco is a very durable material, due to the location's proximity to the shore, spalling due to rebar corrosion usually manifests before the stucco naturally deteriorates. Refer to the table presented at the end of this report.

Estimated Cost of Replacement: The removal and replacement of all the stucco finish is rarely required. It is typically repaired as required in the building for general maintenance. Therefore, we assume that 20% of all exterior surfaces are required to be replaced at once. See the table presented at the end of this report for our recommendation based on our experience and the size of the building. (The exact amount of area needing replacement will be discretionary based on the actual future conditions and the desired appearance).

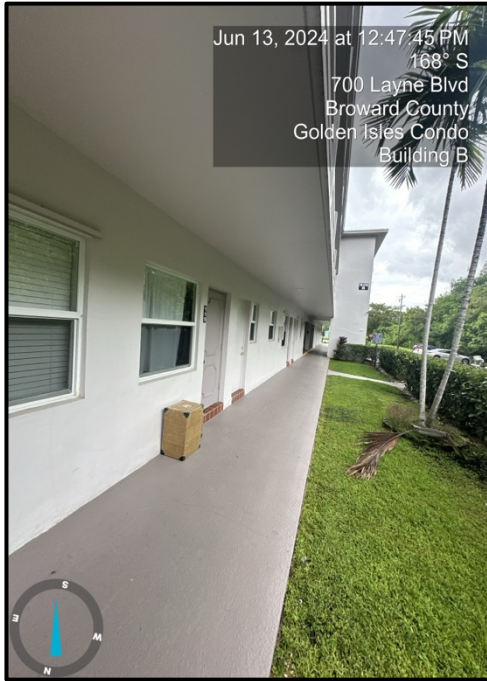
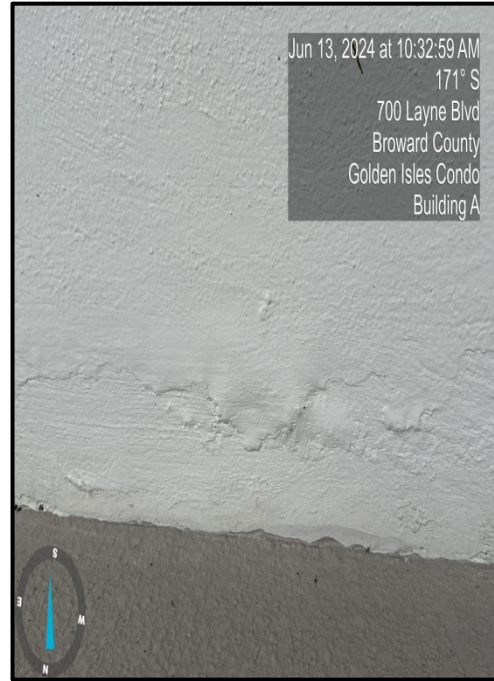
EXTERIOR FAÇADE – PAINTING & WATERPROOFING

Condition: The surfaces appear to be in fair condition.

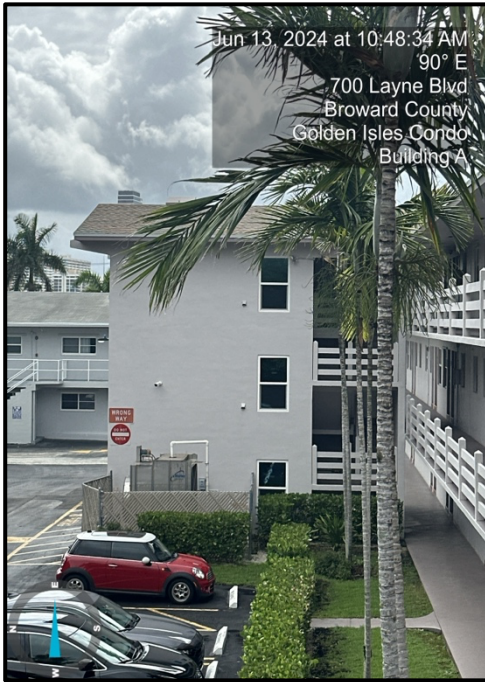
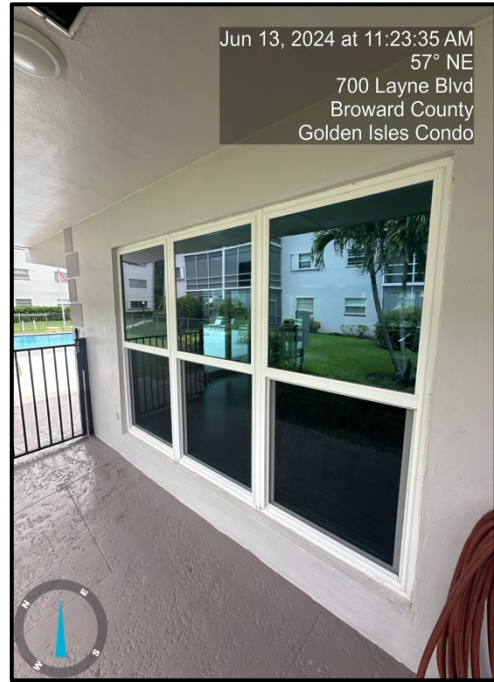
EXTERIOR WINDOWS & DOORS (COMMON AREAS ONLY)

Condition: The common area windows and doors appear to be in fair condition. The association is only responsible for the common areas. The units' windows and doors are the unit owner's responsibility.
